COTTON WAR MEMORIAL

CONDITION ASSESSMENT REPORT

May 2018

Matthew Beesley ACR

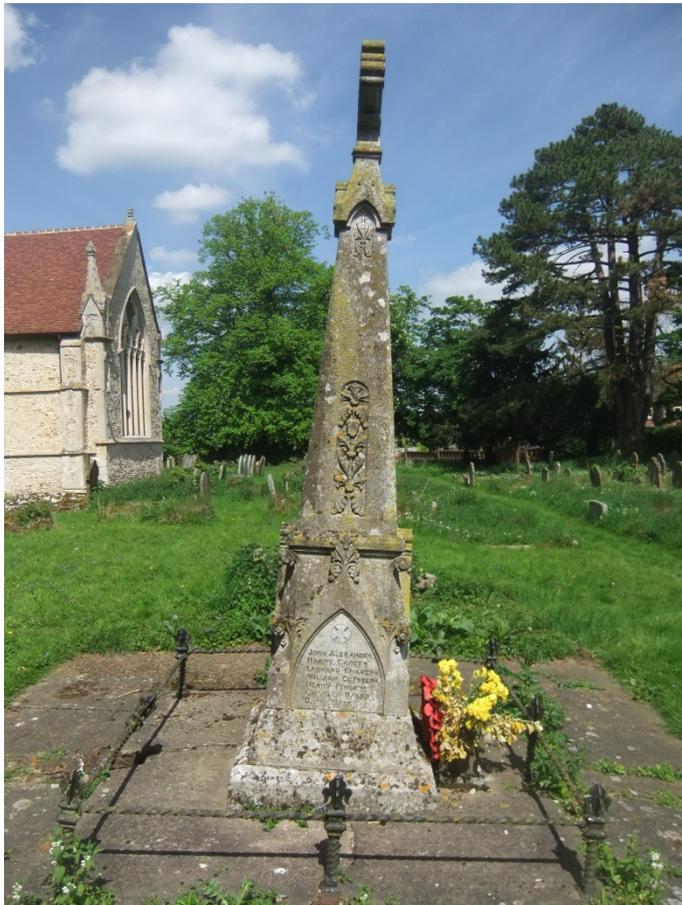
Figure 1

Despite having a forward lean toward the east (**Fig. 1**), and stepped fissures to the 50mm thick concrete apron immediately surrounding the memorial (**Fig. 2**), it was not possible to remove sufficient quantity of the apron, to visualize materials beneath. However the investigation revealed a chamfer sided kerb (**Fig. 3**) and paved ledger slabs that are likely to be original to the memorial's design. This condition assessment is a summary of salient points noted on the day.

Plumb-line / spirit level measurements showed a ~ 10mm tilt to the west, and ~ 3mm tilt to the south. Despite this, there are no discernible movements or fissures between joint lines to the stem's base or inscription panel. Apart from localised external weathering to joints, the mortar adhesion and condition is still very firmly bonded between components (**Fig. 5**).

To upright and level the monument, following the clearance of concrete paving slabs and ascertaining the condition of kerbing / stone slabs for re-use, it is possible to provide firm packing by insertion of slate and mortar. Soil consolidation may be required with an eminently hydraulic mortar, mixed with the soil to the east side, as a strip foundation to reduce any rotational forces of early settlement. Repointing using an hydraulic mortar (NHL 2/3.5: Aggregate 1:2), would also be of benefit where required, although the pointing is generally in excellent condition.

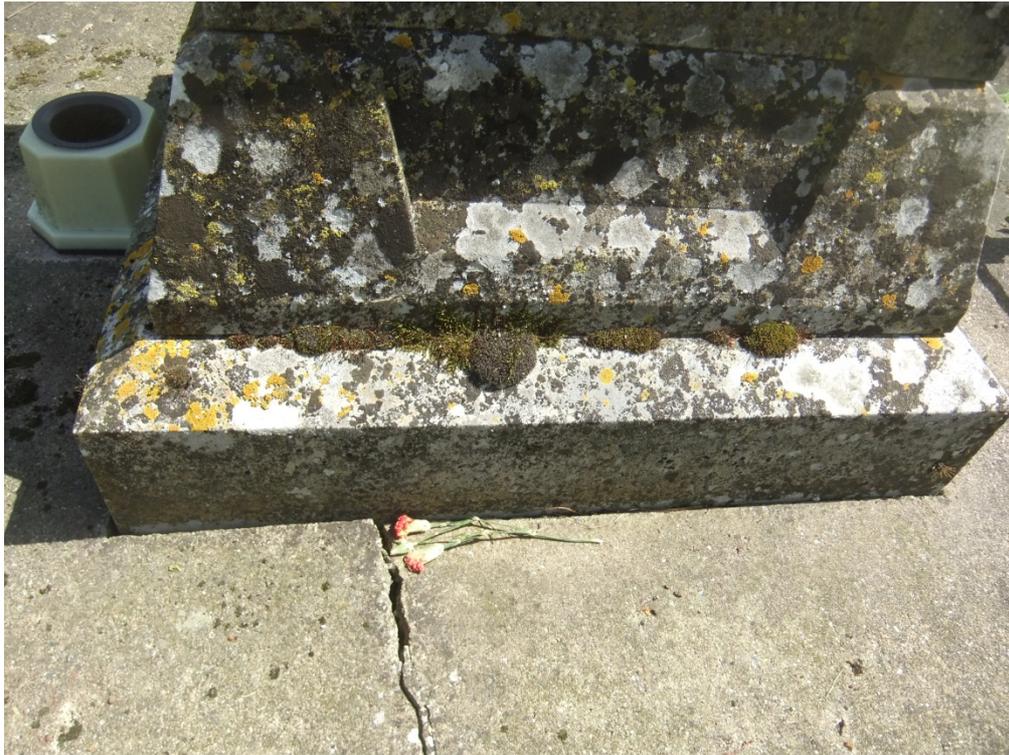
Figure 2

The overall footprint dimensions including the surrounding concrete slabs, is 396 cm². One metre from the edge of the north pavement is the centre point of Yew tree stump, recently cut down. The combination of soil moisture uptake and root systems of the Yew are likely to have contributed to the uplift and distortion of the slabs and sub-soil disaggregation.

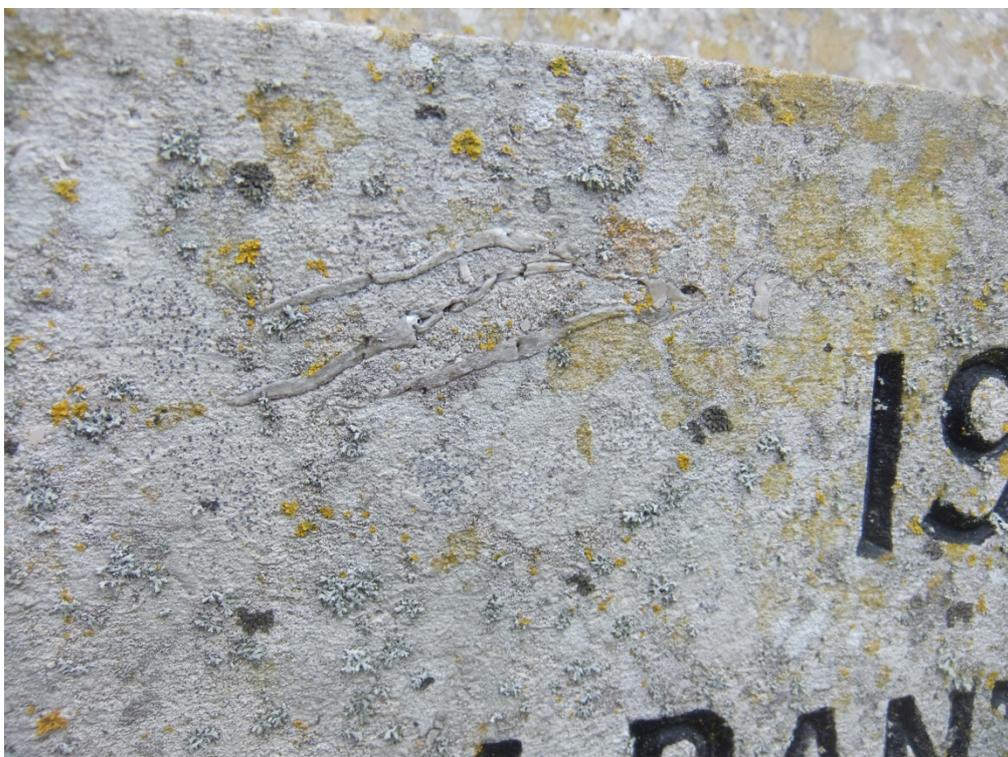
Figure 4

The memorial design is composed of 6 units of stone, from the two plinth and base stones, through the carved cusp, finials, sunken inscription panel, to the shaft, shaft head, and cross. The stone is fine grained, with occasional molluscan casts and bioclastic sediment, horizontal and natural bedded (**Fig. 4**), which appears to be the Basebed type of Portland stone.

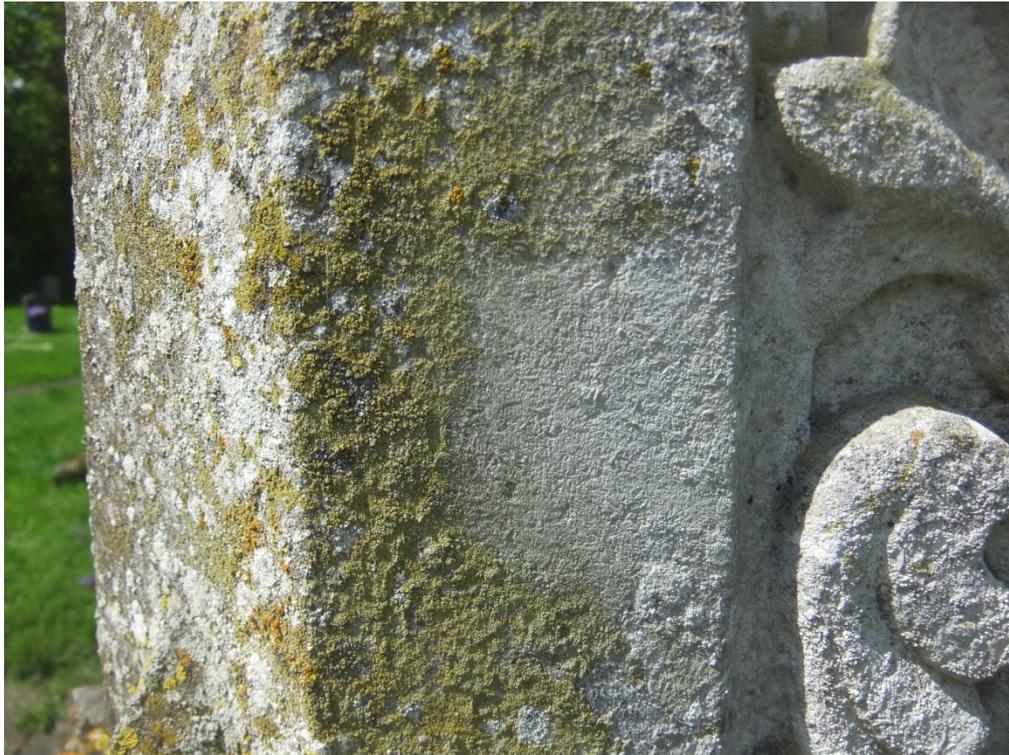
Figure 6

Various lichen species, mosses and algae have colonised the stone (crustose, leprose, fructose). The paler light green crustose lichen has given rise to shallow root ingress (**Fig. 6**), with the oxalic acid as a by-product during the acid-base exchange mechanism. However, with surrounding species being less chelating in nature, it is likely that a symbiotic balance has occurred, with protective calcium oxalate mineral transition, and some hydrophobicity. North (N) and North-East (N.E) elevations are more prone to algal and moss deposition, particularly to convexed carved detailing and joint lines (**Fig. 7 and 8**).

For cleaning the memorial, there may be display value in applying a non-hazardous solution of Algo Bio Inhibitor (Supplier: Tensid 01932 554133) which would allow a partial removal of micro-florae, permitting rainfall to effectively clean the memorial but allow patinas to remain. Pressurised steam cleaning is likely to prove difficult in the removal of darker lichens, and algal regrowth may re-occur within 6 months. The Algo Inhibitor is residual for 2 – 3 years. Another biocide, also non-hazardous, D2 quaternary ammonia compound, would provide a cleaner solution. The threshold level of the change of appearance following cleaning requires discussion; alternatively, it may be acceptable for the memorial not to be cleaned, with the focus instead being on levelling it, and assessing the damage to the sub concrete apron stonework. This would also give some perception of care and value to the appearance. So, trials for cleaning methods would be useful, to establish two cleaning levels.

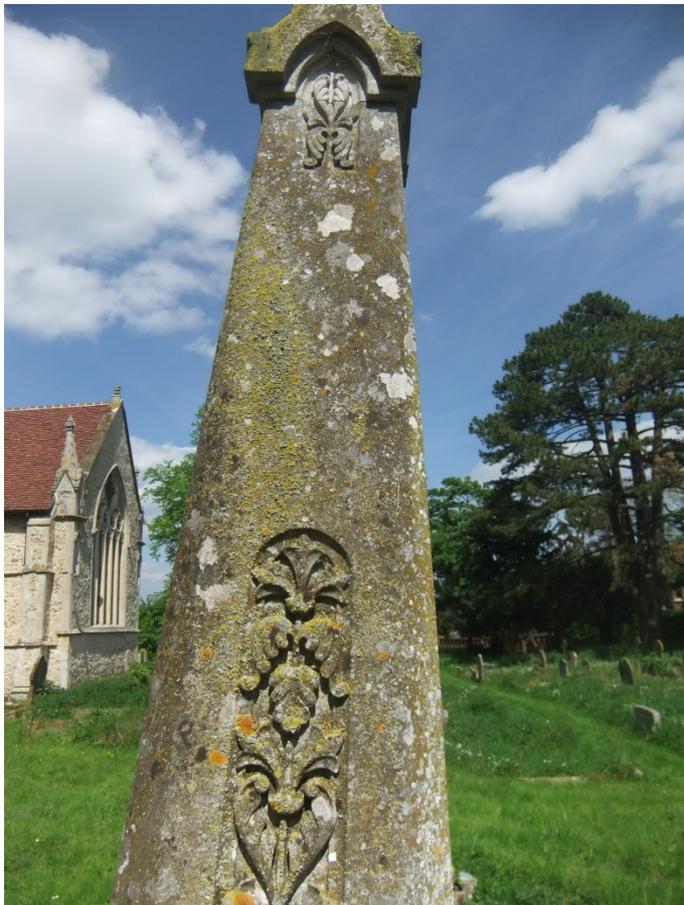
Figure 9

Moisture run-off from the cap stone beneath the cross has led to a correlating specific crustose lichen species, possibly sulphur fixing, following the water line demarcation, on the south side (**Fig. 9**). On the World War II panel is a particularly interesting red algae, noted also on surrounding gravestones.

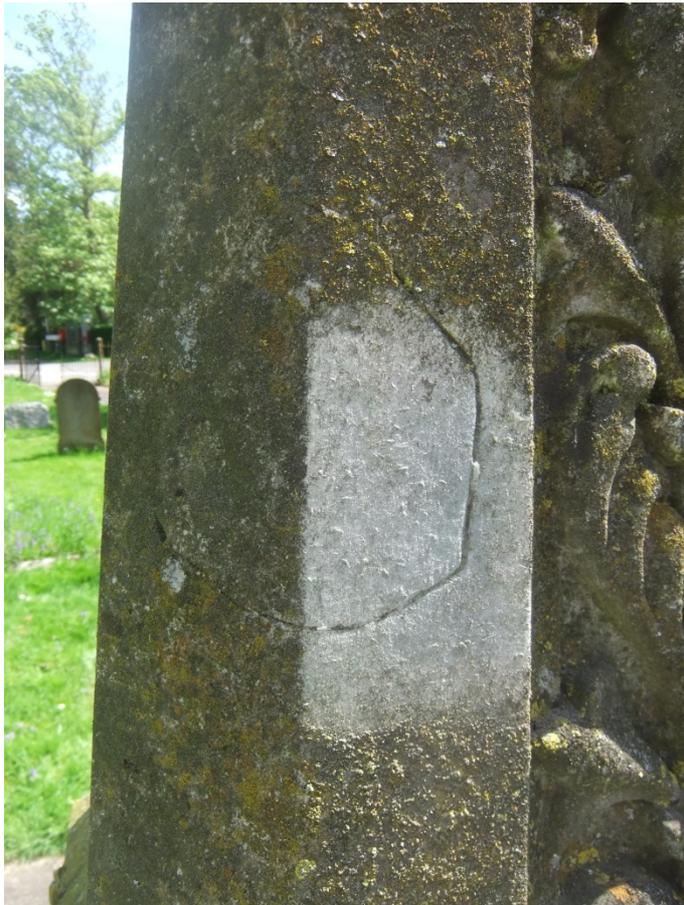
Figure 10

An original stone indentation repair is on the N.W corner; the weathering of the indent is identical to the surrounding stone surfaces (**Fig. 10**).

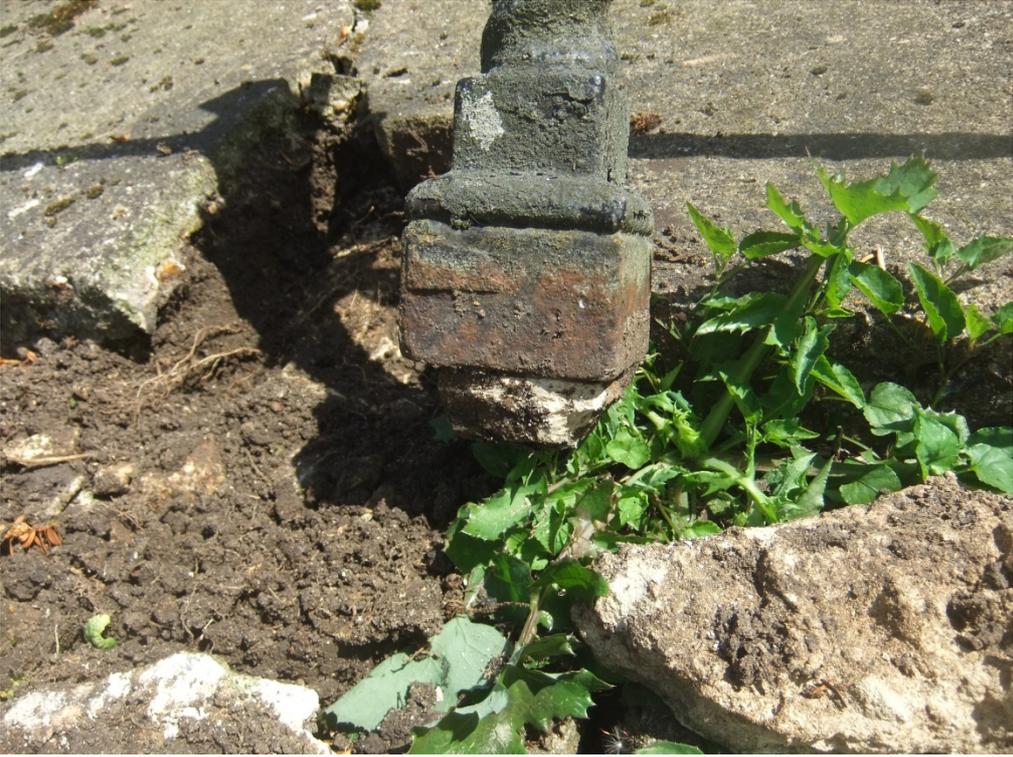
Figure 11

The low level metal decorative fence is attached to what appears to be a Caen stone kerb / step, by utilising a stone mortice recess for the ferrous tenon, the shoulder of which rests directly upon the stone (**Fig. 11**). Subsequent iron expansion has split the stone, including part of a visible paviour slab between the kerb and the memorial base. Further exploration is required to see whether the original memorial included the surrounding paving stones and kerb sets / steps, which may have effectively composed / framed the memorial in a subtle and effective way, in part structural to shed water, and in part decorative by using the shift in stone colour. It appears that the metal fencing is relatively modern, inserted at the same time as the concrete apron (**Fig. 12**).
